Subject:	<b>Toyota vehicles where the A/C switch lamp “blinks” continuously and the A/C is not functioning. The Toyota Camry in particular.</b>					TSB #:	<b>27 2-10</b>
						Date:	3/2/10
Initial Once Read:

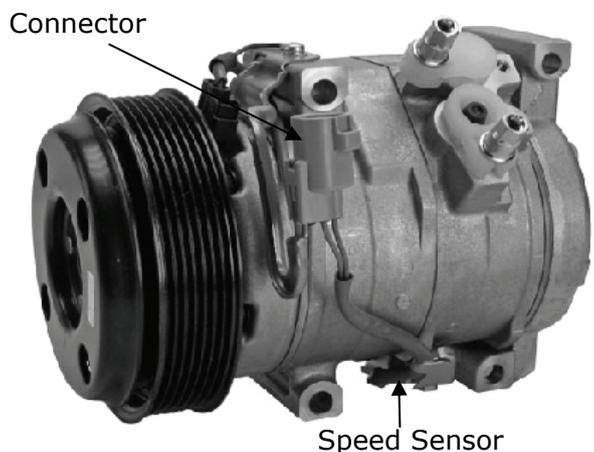
The speed sensor on Toyota vehicles is located in 2 positions on the compressor body either at the rear head or underneath, the sensor wiring is attached to the clutch field coil wiring connector. The connector normally has four (4) terminals, two (2) to the clutch field coil and two (2) to the speed sensor.

Testing: Disconnect the negative battery lead, then the compressor electrical connector. Using a multimeter check the sensor resistance between the connector terminals attached to the sensor wires (you may have to slide back the insulation to see the wire colours)

The electrical connector contains four (4) male terminals. Two are for the clutch field coil, two are for the speed sensor.

4 Cylinder engine 2.2 / 2.4ltr = 165 - 205Ω

6 Cylinder engine 3.0ltr V6 = 65 - 125Ω

If the Ω value obtained is under or over replace the speed sensor or if the compressor is hard to turn replace the compressor assembly.

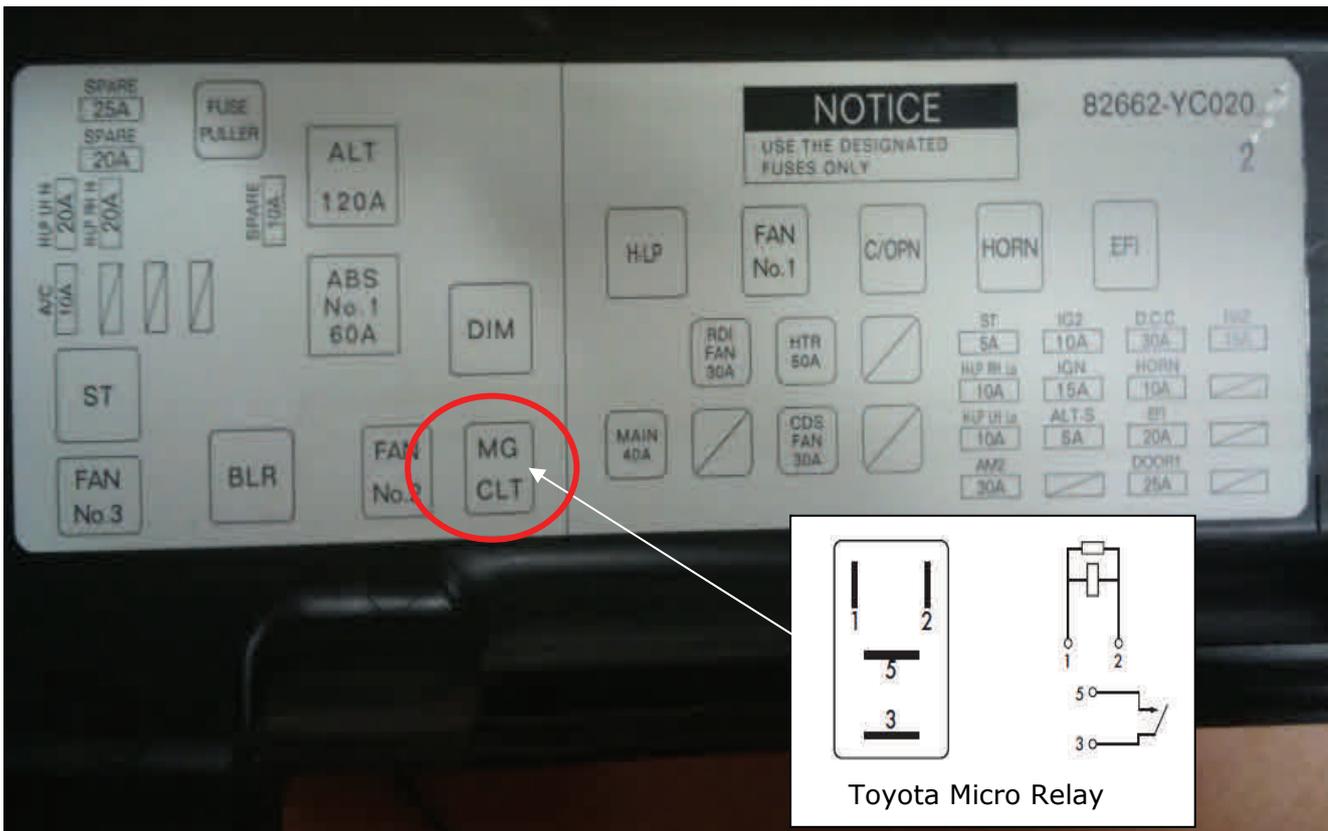
Check for voltage at the electrical connector of the compressor with the ignition ON and A/C ON. If there is 0 volts check for a blown A/C fuse, faulty pressure switch (cause 2) faulty wiring or connector also check the “MGCLT” magnetic clutch relay located in the fuse / relay box in the engine bay. The MGCLT relay is a micro design, Four (4) male terminals and the plastic case –white, Toyota part number 98987-82022 / 156700-2470. Location of relay is in the fuse / relay box in the engine bay area (see relay box cover picture below)
