Subject: <b>A/C REFRIGERANT HOSE DE-LAMINATION</b>	TSB #: <b>34 2-10</b>					
	Date: 3/10					
Initial Once Read:

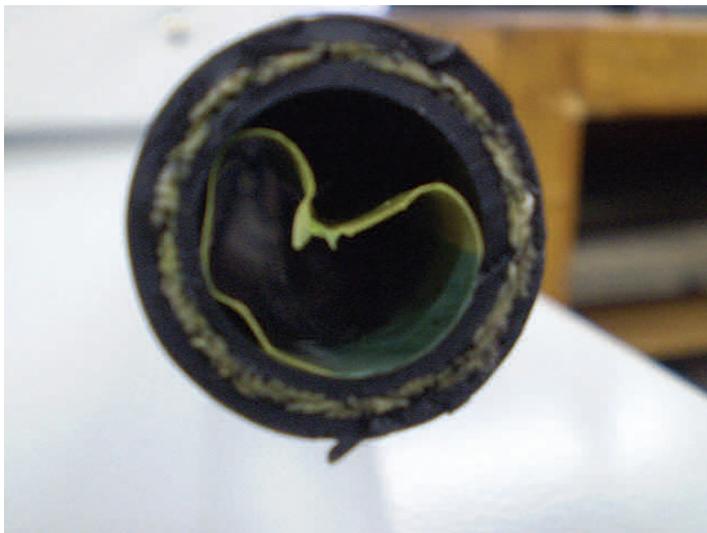
The only other component on the Low side that could have contributed to the issue was the Suction hose. This was removed and inspected on the outside it appeared to be okay it was only when Richard bent the hoses that a "crunching" noise was heard.

The Suction hose was cut open which revealed that the inner nylon lining had de-laminated from the hose which caused a restriction or blockage especially above idle speed when the compressor is turning faster and pulling more refrigerant from the evaporator.

In both these cases the refrigerant hoses were routed closely to the exhaust manifold and the assumption is that over time the exhaust heat had affected the hose and lead to the internal hose de-lamination.

Toyota land cruiser suction hose nylon inner lining de-laminated from the inner rubber section.

Consider this issue when diagnosing, as your pressure gauges could indicate the same pressure readings as a blocked evaporator or TXV. Check the routing of the High and Low side hoses to see if they run close to the exhaust manifold, secure if necessary.

Ensure that as part of you're A/C system inspection that all the A/C hose clamps are fitted to prevent any hoses or tubes from being too close to the exhaust manifold or other engine ancillary components.
