ADDITIONAL INFORMATION FOR TECHNICAL BULLETIN TSB55 REGARDING THE HONDA CL ACCORD EURO					TSB #:	56
					Date:	6/1/2012
Initial Once Read:

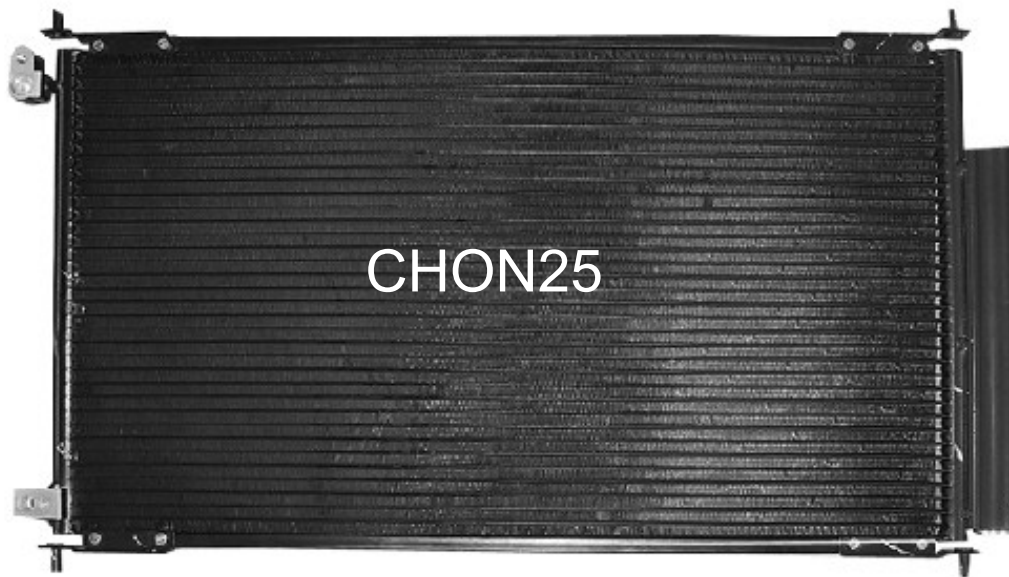
Compressor seizure is not an uncommon issue with these vehicles and as James has repaired quite a few, he recommends that the multi-flow condenser must also be replaced when replacing the compressor. Metallic particles, teflon material and burnt oil from the damaged compressor will end up in the condenser inlet and it doesn't matter how many times you flush the condenser, all the contamination will not be removed (black death). This will eventually lead to another potential compressor failure at a later date.

The Adair part number for the 2003—2008 CL Honda Accord Euro condenser is CHON25. There is also no need to reduce the original refrigerant charge as mentioned in TSB55, charge the A/C system to 525 +/-25 Grams of R134a.
