<b>COMPRESSOR PMAZ23 FOR THE MAZDA 3</b>					TSB #:	<b>61</b>
					Date:	<b>24/5/2012</b>
Initial Once Read:

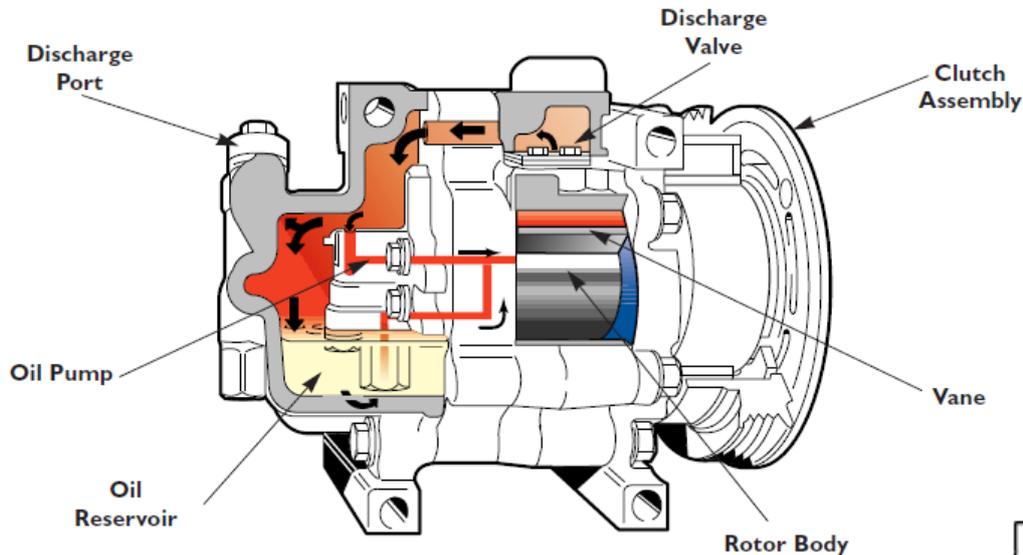
1. *Internal vane "rattling" noise heard on initial compressor engagement at idle.* The vane noise should normally disappear in a matter of minutes. If the noise does not disappear after 10 minutes, hold the engine speed at approximately 3,000 rpm for 5 minutes. The vanes located in the rotor body require both refrigerant pressure and lubricating oil to act as a cushion behind the vane. The cushioning effect ensures full sealing of the vane against the cylinder wall.

Internal view of a National Panasonic vane compressor provided by Air International Thermal (Australia)
