<b>POOR A/C COOLING AND COMPRESSOR FAST CYCLING</b>					TSB #:	<b>71</b>
					Date:	<b>9/1/2013</b>
Initial Once Read:

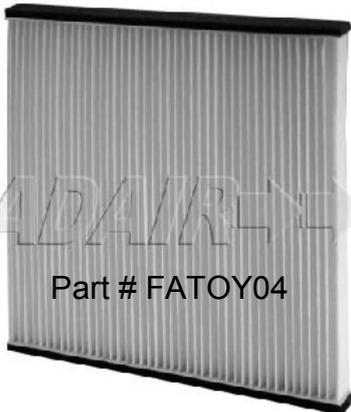
<p>New Adair Cabin Filter</p> <p>Part # FATOY04</p>

<b>CAUSE or REASON:</b>	The air was restricted going into the vehicle cabin, hence the blower fan air flow on the highest speed was very poor. With air being "pushed" through the evaporator at very low air flow, the evaporator was not under any heat load and quickly reached the compressor cut off cycling point.  The cabin filter was replaced and the system is now operating okay.
<b>SUMMARY:</b>	Always ensure that as part of your A/C service or fault diagnosis that you check if a cabin filter is fitted. If it is dirty or clogged — replace it. We suggest every 15,000km or 12 months, but you should consult the manufacturers handbook for their recommendation.  It is a good idea to write the date you install the new cabin filter on the side of the filter in black marker pen for future reference.  Don't forget to include the cabin filter blockage as part of A/C system diagnosis.
<b>PHOTOGRAPH:</b>
